Novel repair of costal margin rupture with preoperative 3D planning

Casey T Walk

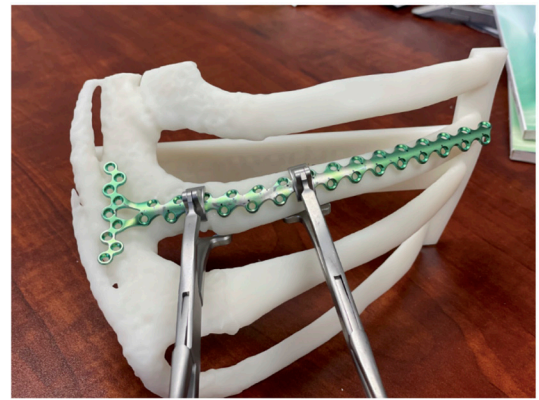
Figure 2 Preoperative planning 3D printed chest wall to pre-mold rib plate.

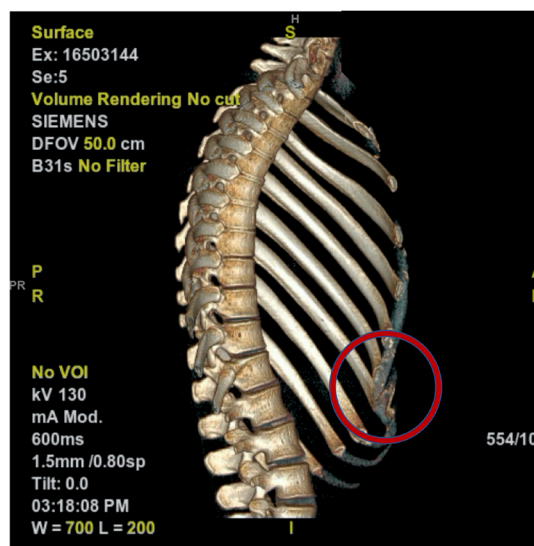
Rib plating for acute rib fractures is well researched and practiced in the trauma setting for specific indications, although the research on costal margin rupture is limited. This is a presentation of a successful costal margin rupture repair managed via custom rib plating using preoperative 3D planning. This has been shown to be an effective and

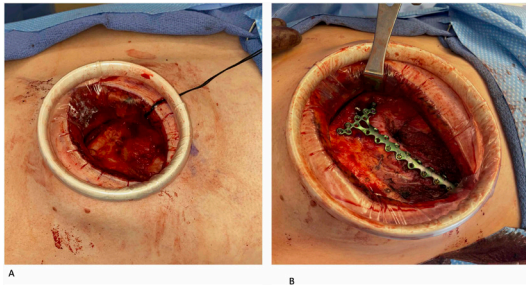
Figure 3 Intraoperative imaging. A- Exposure prior to rib plating. B- Completed rib plating with pre-molded rib plate secured into place noting to traverse the costal margin rupture with T portion secured on costal margin.
